SERVICE INSTRUCTION

RUNNING MODIFICATIONS ON ROTAX® ENGINE TYPE 912 AND 914 (SERIES) SI-25-1997

Running modifications on ROTAX® engine type 912 and 914 (series).

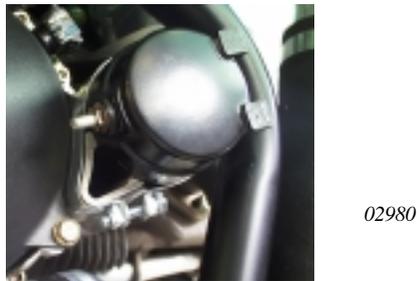
Bild / Fig. 3

The trigger coil kit, part no. 965 175 and the trigger coil for the rev-counter, part no. 264 080 can not be supplied any more as from now on. For parts service the trigger coil kit **965 177** and rev-counter trigger coil **264 085** have to be ordered. Old and new version of these items are interchangeable but take note of the different trigger gap.

Trigger gap for trigger coil kit part no. 965 177: **0,3 - 0,4 mm**
